WHITE'S POND DAM

NH 00106

PHASE I INSPECTION REPORT
NATIONAL DAM INSPECTION PROGRAM

AUGUST 1978

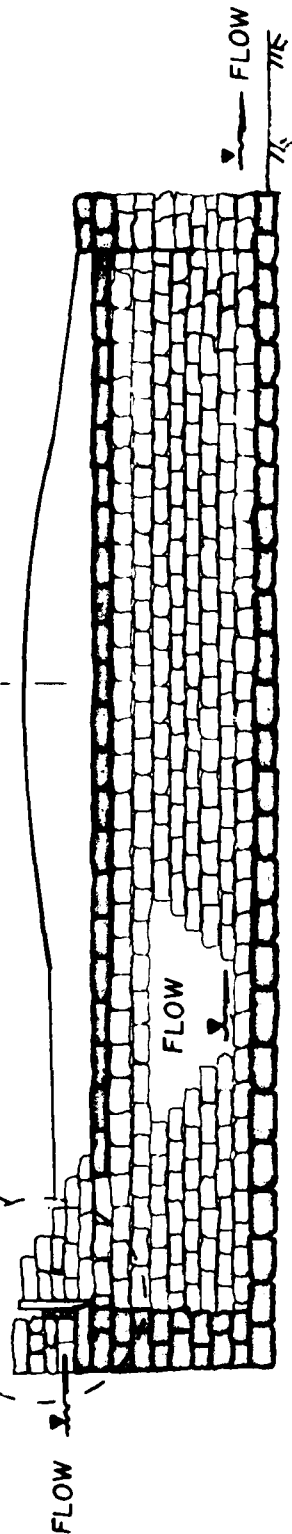
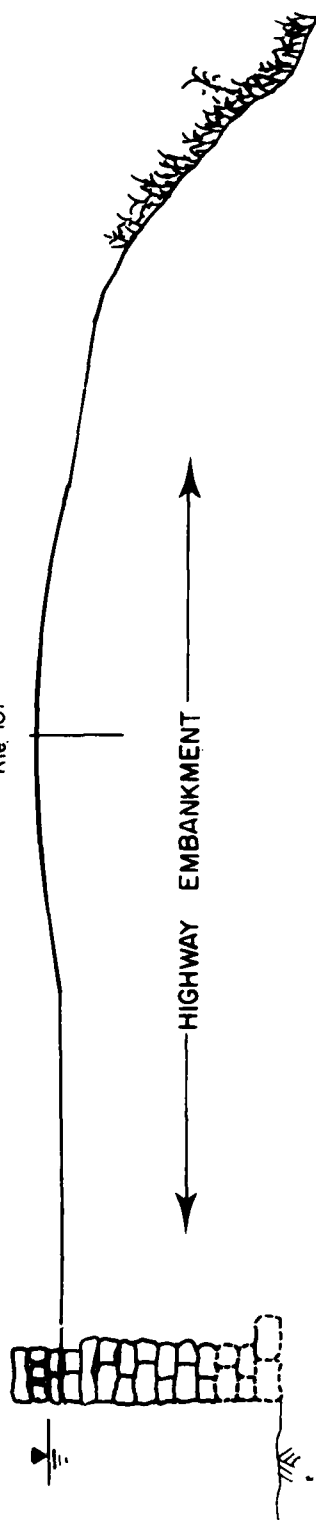
FIG. 3

The double courses of granite, with capstone, which form the dam proper were somewhat unequal in alignment, consistent with early construction techniques (Fig. 3 and Overview Photos). However, displacement pond-ward is evident probably caused by former trees, since removed. One tree, a probable contributor to the movement, still remains. Since the outlet of the dam is located opposite the sag point of Rt. 107 with no controlled drainage, storm runoffs flow towards the flume section and the outlet headwall. This condition has caused surface scour adjacent to the flume walls (Photo 1) and undermining and loss of ground at the northeast wing wall.

The spillway structure consists of squared stone granite masonry with unmortared chinking stones (Figures 3, 4, and 5). The spillway is 11.5 feet long by 3.3 feet wide with a 10 foot vertical drop between the spillway sill and the flume invert. A nominal 3 inch by 21 inch timber stop-log is set on top of the spillway and secured by means of restraining angles bolted to the sidewalls of the adjacent flume. The invert of the spillway is 3.7 feet below the top of the granite block facing of the dam. It was observed that continuous seepage is permeating through the second joint coursing of the granite dam facing adjacent to both sides of the spillway; the second capstone joint being below pond level (Photo Nos. 2 and 3).

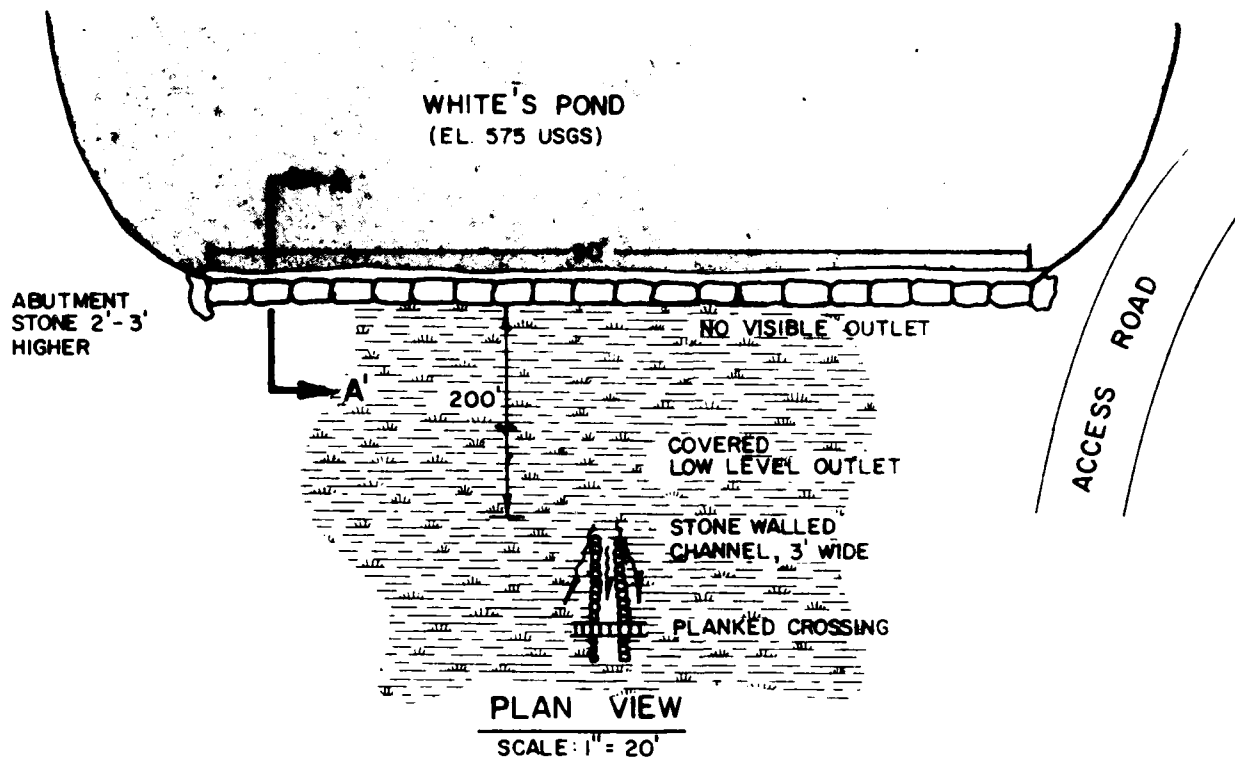
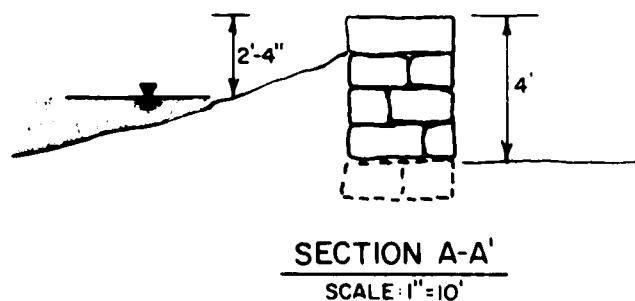
FIG. 6

The 90 foot long, 4 foot high closure structure on the northside of the pond is, as is the dam proper, constructed of double-wall granite blocks with capstone (Figure 6). It has recently been remortared in several locations, and is in fair condition.
